Motorola Solutions Technical Notification (MTN)

TITLE: MOTOTRBO™ Capacity Max Repeater Control Channel stops in the presence of interference

TECHNOLOGY: MOTOTRBO™ Capacity Max

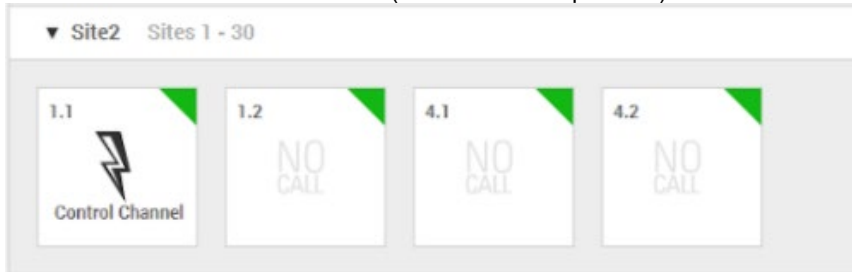
Picture 1: Site with Control Channel (normal/correct operation)

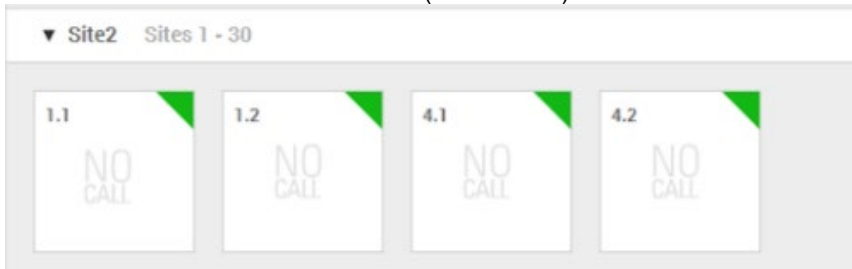
This issue can be confirmed by looking at the Call Monitoring Grid View page in System Advisor. The site with affected repeaters will indicate that all channels are active (green) with no Control Channel as shown below on Picture 2:

Picture 2: Site without Control Channel (affected site)

To recover system operation, restart repeater from System Advisor or repeater Webpage. The repeater will resume operation within 2min.

Download the new Repeater firmware version **R20.20.02.06** (M2020.02.02 release) or later from the MOL or MyView site and perform a Repeater firmware upgrade to that version.
