Motorola Solutions Technical Notification (MTN)

TITLE: PMNN4547A showing “Unknown battery” error display on Multi unit charger

TECHNOLOGY: IMPRES 2 Battery

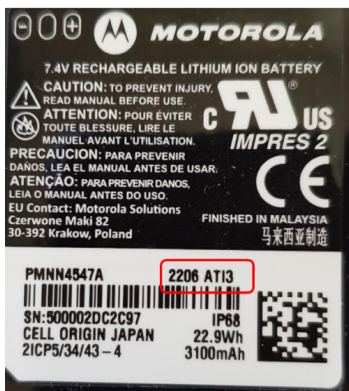
Error is only seen on NEW out of box batteries. Certain lots of PMNN4547A showing ‘Unknown battery’ error permanently on multi unit charger. When these affected batteries are used with a single unit charger, the charger LED will not light up for the initial 7 seconds before showing a solid RED LED.

PMNN4547A with date code 2206 and the manufacturing codes specified in the table are affected. Other manufacturing codes are NOT affected.

Refer the image below on location of date code and manufacturing code

An error in the programming station in the manufacturing process has resulted in a certain quantity of batteries to be missing the required data to make the battery function correctly.

Affected units can be replaced under Warranty by calling 800-422-4210 Prompt 2, 2.

Reference MTN-0246A-21-NA and original FO (Factory Order) number when ordering replacements
