## Motorola Solutions Technical Notification (MTN)

**TITLE:** Premature low battery alert and/or battery shutdown with SRX2200BN / APX6000BN 700/800MHz radios and NNTN8930A Batteries

**TECHNOLOGY:** ASTRO Subscriber

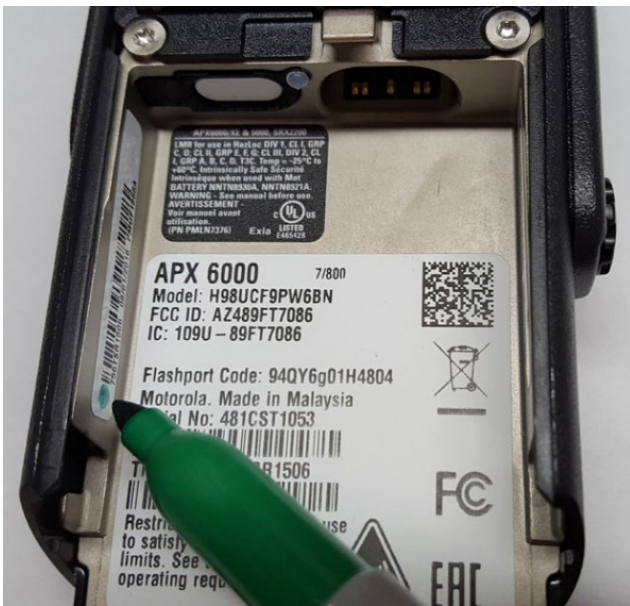
If the radio already has a green dot on the left sidewall of the radios battery compartment (as seen below), the radio will not need to be sent into the depots as it has already had the board modification done
