## Motorola Solutions Technical Notification (MTN)

**TITLE:** APX/PCR RSM Cable Jacket separation/fraying exposing internal wires

**TECHNOLOGY:** Accessory - APX/PCR Remote Speaker Microphones

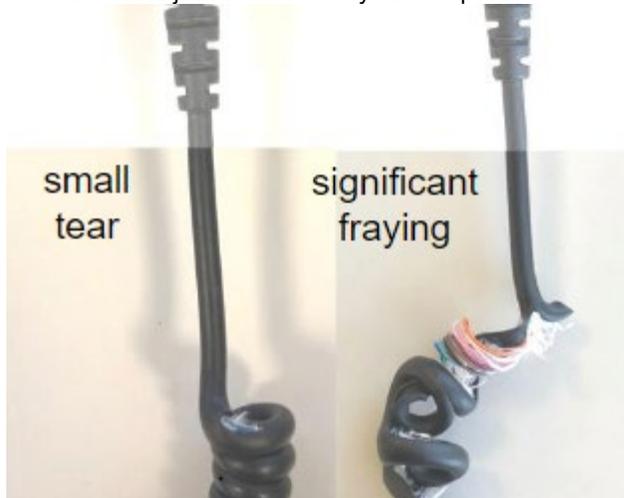
The RSM cable jacket tears or frays and exposes the internal wires. See the example picture below..

Cable tear or fray is a condition in which:

- the RSM cable black outer jacket develops frays that get worse with use
- the inner cable contents become visible
- typically occurs at RSM head or radio connector (GCAI) end or both, but can also occur in cable middle section.

Motorola will extend the warranty to 2 years (1 year beyond the standard RSM warranty period) for units that exhibit the cable fraying issue.

The following lists show which model RSM is to be used for replacement with the larger coil diameter solution.

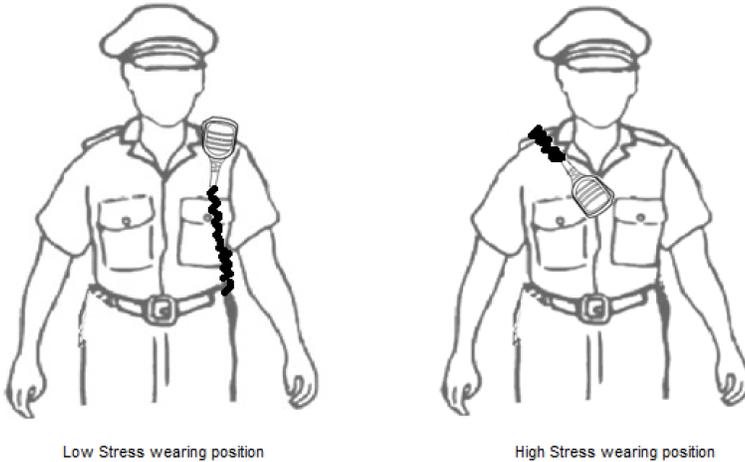
Motorola RSM cable jacket material was changed in 2013 in order to comply with changes in global environmental material regulations. In the RSM cable application, the compliant jacket material has demonstrated a greater susceptibility to tearing at points of stress induced when the coil is elongated or stretched. How the RSM is positioned on the body (i.e across the back and over the shoulder vs. along front of the body - see picture) directly affects potential induced coil stress.

Susceptibility to the cable jacket tear phenomenon has been significantly reduced by increasing the coil diameter which effectively reduces coil cord stress. Motorola strongly recommends RSM users to dress the RSM coil section of the cord in such a way that it does not get caught on uniform accessories and equipment or equipment worn on the person for optimal RSM service life.
