## Motorola Solutions Technical Notification (MTN)

**TITLE:** Recommended best practices - installation Guide for MOTOTRBO™ mobile radios

**TECHNOLOGY:** MOTOTRBO™ mobile radios

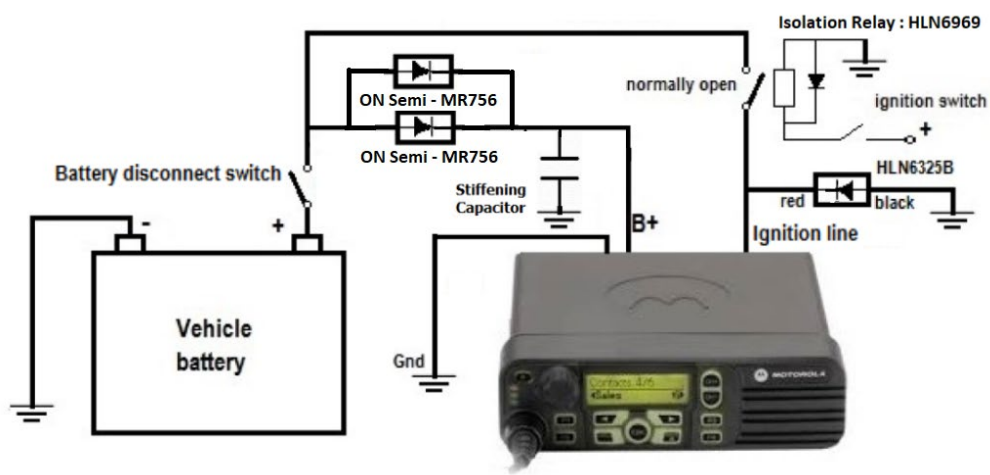
**Wiring Diagram-1**

Excessive Power supply noise, interruptions, and/or acute power fluctuations beyond radio's rated power supply voltage **10.88Vdc** ~ **16.3Vdc** causing radio operation anomalies.

- CPS programming change to disable Emergency feature in radio personality if the Emergency feature is **not** used
- Inspect emergency Footswitch for faulty switch and/or corroded connections
- Clean/replace any corroded connections
- Solder wire connections and use Antioxidant Compound to protect connections from corrosion as needed
- Use of a Stiffening Capacitor with a diode to minimize acute power fluctuations. Please see **Diagram-1** for wiring illustration. A recommended value for a Stiffening Capacitor may be **1000** to **10,000 uFd**, **50V** surge or higher.
- Prior to battery maintenance being performed, it is recommended to properly power down the radio followed by removing the Fuse on the radio power supply cable. Location of the Fuse is shown in **Diagram-2**. Please remember to reinsert the Fuse after battery maintenance is completed.
