## Motorola Solutions Technical Notification (MTN)

**TITLE:** MOTOTRBO™ MTR3000/XPR8400/XPR8380 repeaters potential issue when performing upgrade.

**TECHNOLOGY:** MOTOTRBO™ MTR3000/XPR8400/XPR8380 repeaters

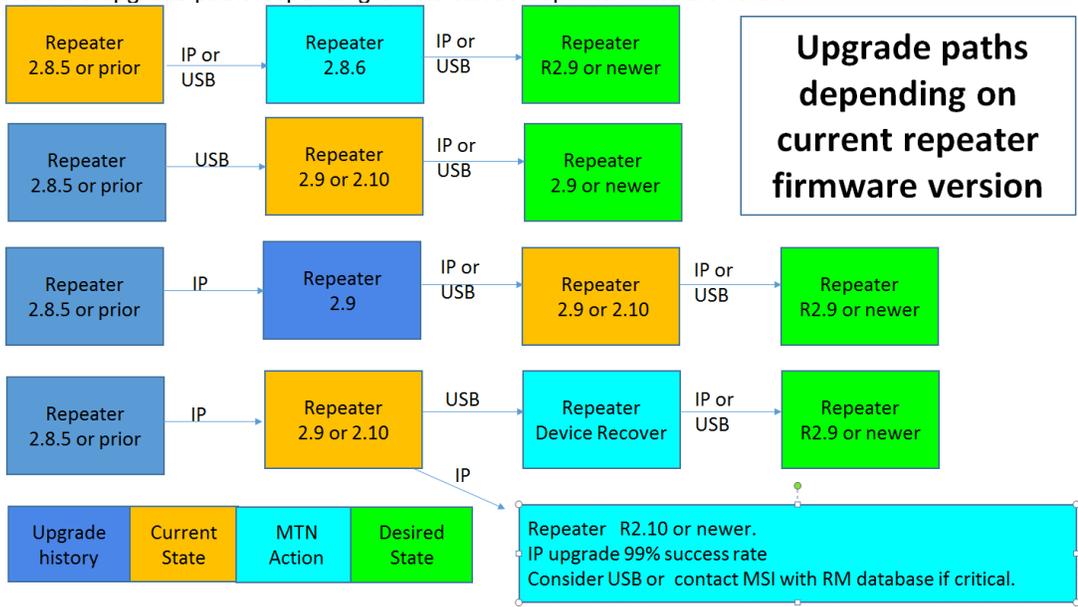
# APPENDIX A: Upgrade Paths

Possible upgrade paths depending on the current repeater firmware version:

For repeaters on **R02.08.05.03** firmware or prior versions, download the **R02.08.05.06** (MOTOTRBO R2.8.6 release) repeater

firmware package from Motorola Online (MOL) and upgrade to this version via IP (or locally via USB) first to remove the potential for this issue and then upgrade to the desired version.

For repeaters on R2.9 or R2.10 release, to eliminate a chance of occurrence, before upgrading the repeaters perform a device recovery first, reapply the configuration and then upgrade to the desired version.
