Motorola Solutions Technical Notification (MTN)

TITLE: MOTOTRBO™ MOTOTRBO Network Interface Service (Data Gateway, MNIS) Error#4201 when launching the application

TECHNOLOGY: MOTOTRBO™ Capacity Plus Multi Site (Linked Capacity Plus, LCP)

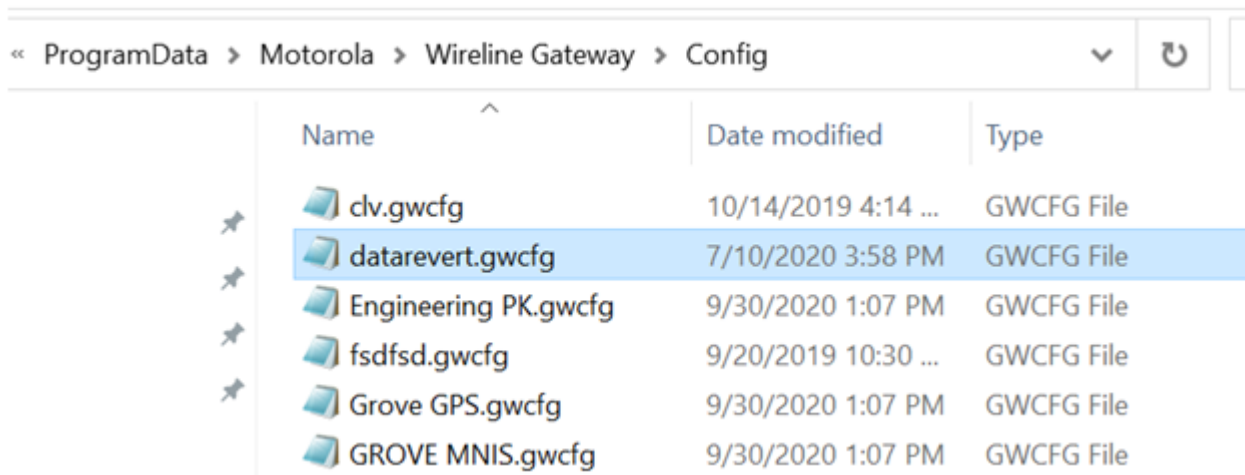
1. Open the MNIS Config file in a Text Editor. The config file can be found in this folder: C:\ProgramData\Motorola\Wireline Gateway\Config as per the screenshot below:
