**Motorola Solutions Technical Notification (MTN)**

**TITLE:** MINITOR VI Pager Intermittent charging issues

**TECHNOLOGY:** Minitor VI - Paging Devices

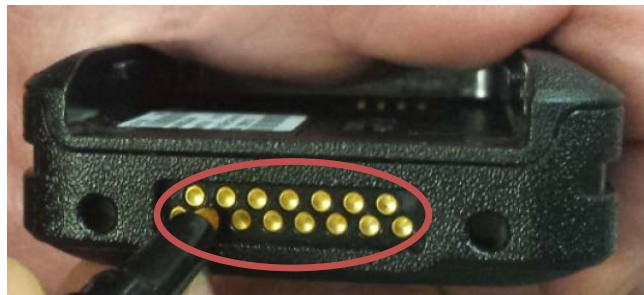
Accumulation of debris (dirt, fibers and other non-conductive material) in Minitor VI I/O connector.

Figure 1 - Minitor VI with I/O connector concave pins

- I/O connector will be replaced with flat pins connector at no charge to the customer.
- Units sent in that already have the I/O connector with the flat pins will not have the connector replaced and returned in the condition they were received.
- No other repair will be performed under this MTN.
- Regular maintenance/cleaning of I/O connector pins on a regular basis as specified in FSB 10966B is still good practice after replacement.

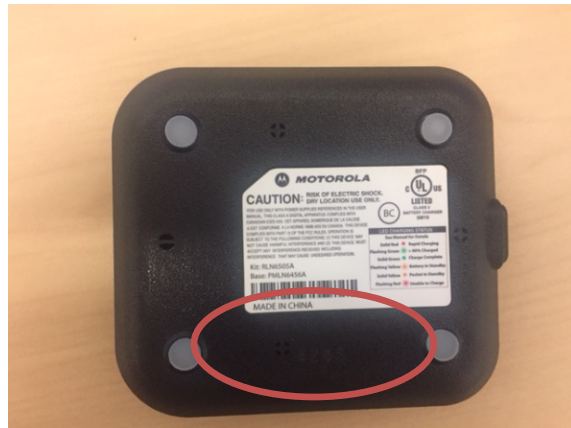
- Minitor VI with concave I/O connector pins (Pre-June 2015).
- Single Unit Charger (SUC) model RLN6505A with date code 5151 or earlier.

Figure 2 - Date code location in Single Unit Charger RLN6505A (engraved)

- I/O connector will be replaced with flat pins connector at no charge to the customer.
- Single Unit Charger (RLN6505A) will be repaired/replaced at no charge to the customer.
- Minitor VI units sent in that already have the I/O connector with the flat pins will not have the connector replaced and will be returned in the condition they were received.
- Single Unit Chargers sent in that have a date code 5152 or later will not be serviced and will be returned in the condition they were received.
- Single Unit Chargers sent in alone (any date code) will not be serviced and will be returned in the condition they were received.
- No other repair will be performed under this MTN.
- Regular maintenance/cleaning of I/O connector pins on a regular basis as specified in FSB 10966B is still good practice after replacement.
